**RABEAA POINT OF ENTRY
SCREENING FACILITY
RABEAA, IRAQ**

**SIGIR PA-09-173
JANUARY 11, 2010**

Summary of Report: PA-09-173

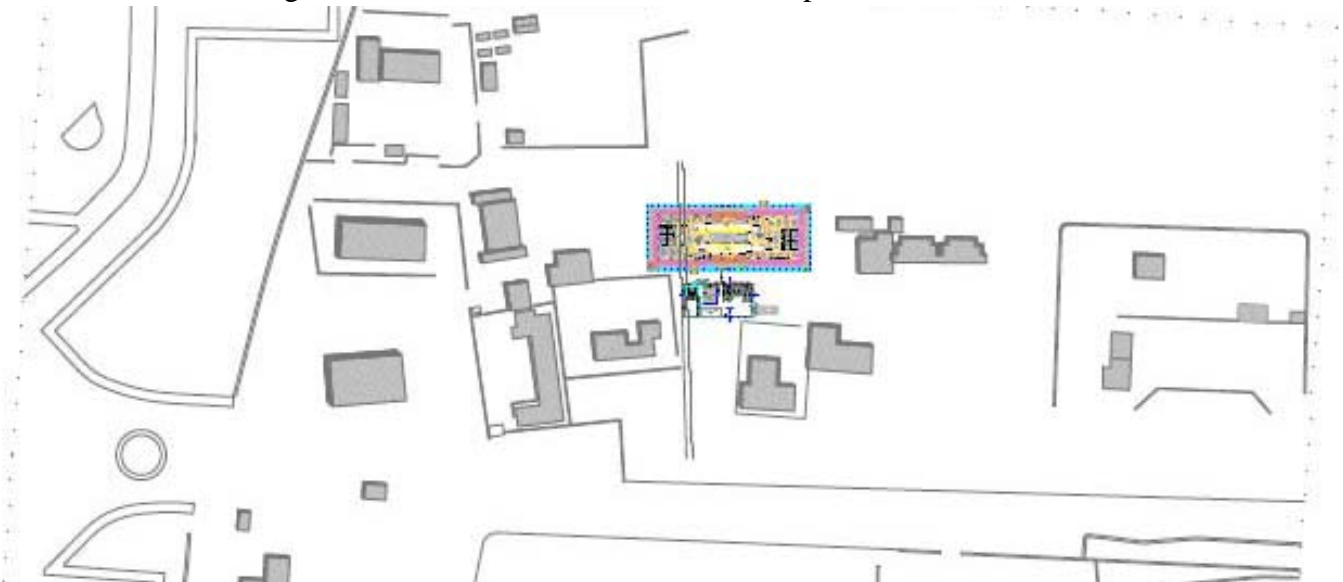
Figure 1. Civil site plan (Courtesy of USACE)

The civil design package included more architectural plans than civil drawings and the actual civil site plan (Figure 1) lacked details on topography, roadways, parking, and other typical site plan requirements. A primary concern was the lack of any drainage plan in the civil site plan. The contractor noted in the geotechnical report that drainage could contribute to future foundation problems.

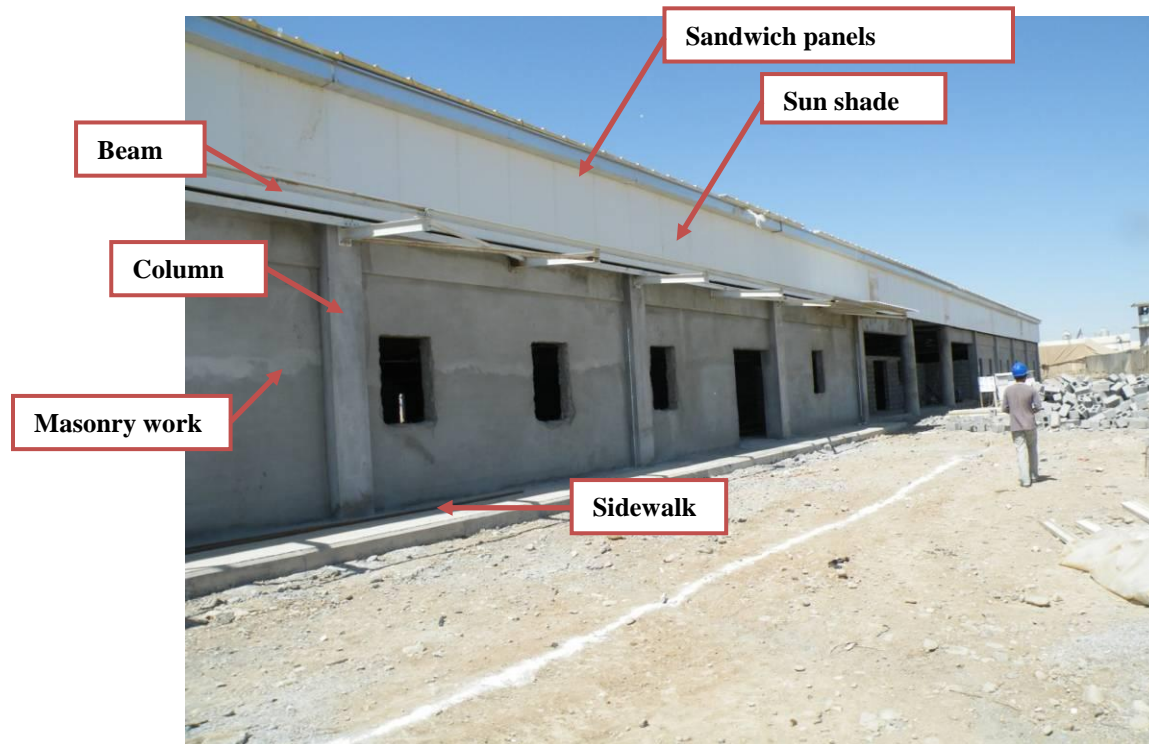
Site Photo 1. Exterior construction of the screening building

At the time of the site assessment, the exterior frame of the screening building was constructed (Site Photo 1). SIGIR observed the construction of the sandwich panels, sun shade, beam, columns, masonry, and sidewalk of the screening building. The interior of the screening building was not complete. The interior walls of the screening area were partially constructed.

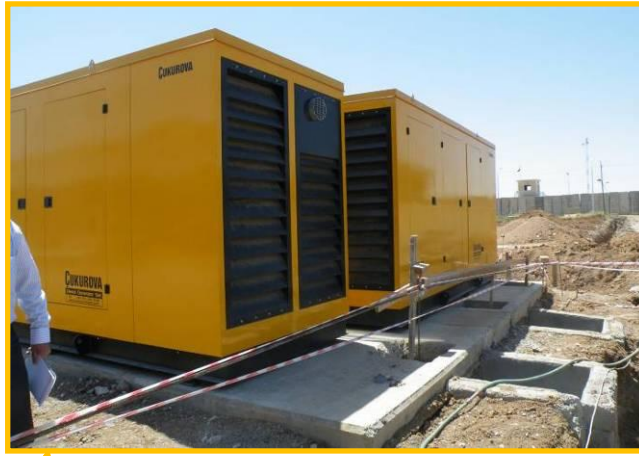
Site Photo 2. Generator pad with generator

At the time of the site assessment, SIGIR noted that the contractor installed the generator on the generator pad (Site Photo 2), constructed the fuel tank base (Site Photo 3), and constructed the pump room (Site Photo 4).

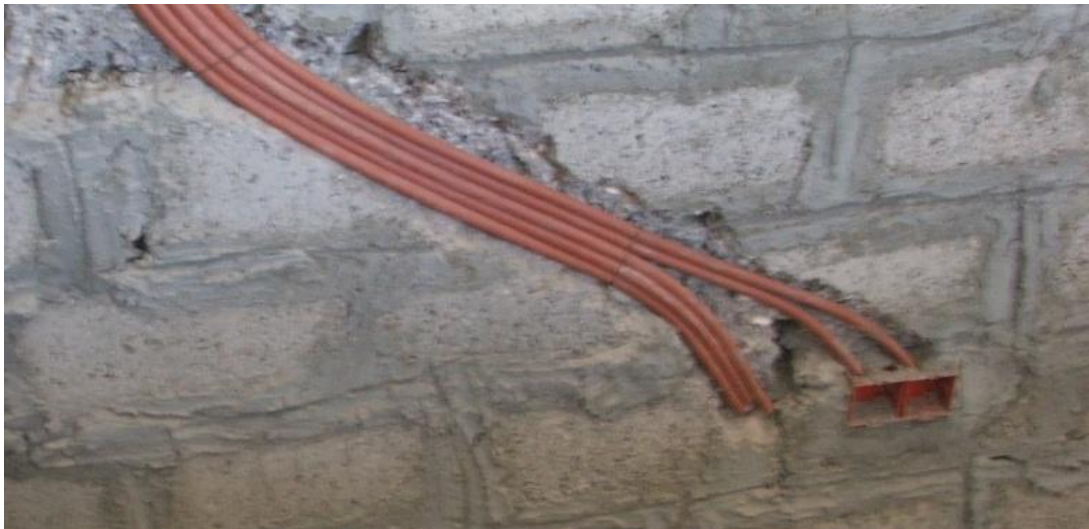
The conduit for future electrical wiring was embedded in the interior masonry walls (Site Photo 5). The SOW, Section 26.2.1 required that all building electrical lines were to be "surface mounted in conduit vice embedded." In addition, the conduit used did not match the COR approved product submittal.

Site Photo 5. Electrical conduit embedded in interior wall

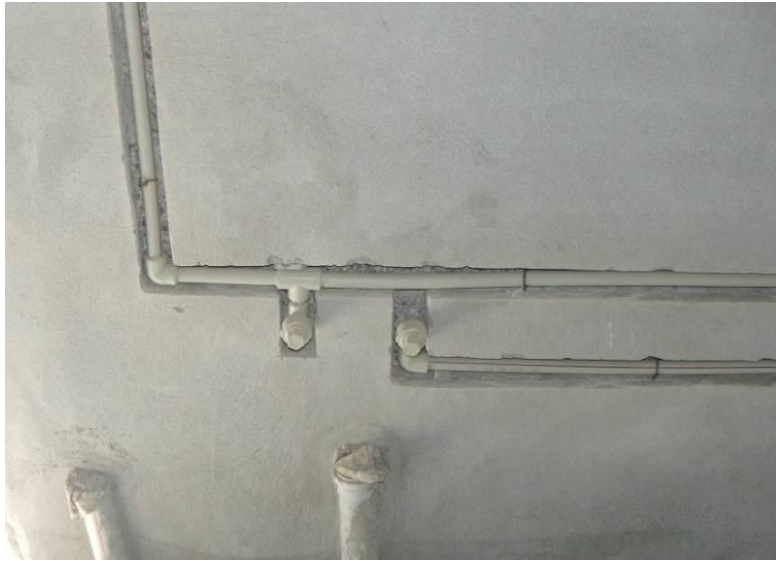
SOW, Section 22.5.3 required the contractor to use "schedule 40 galvanized steel pipes" and the water lines were to be surface mounted. The COR approved the use of a Turkish made product, pilsatherm (plastic) pipe, in a product data submittal. SIGIR noted that the COR approved a different water pipe product even though the pilsatherm pipe data submittal was unclear whether it met the International Plumbing Code standards as required by the SOW, Section 21.1.1. Also, the COR did not provide a contract price adjustment that should have been calculated when approving cheaper products and installation methods. At the time of the site visit, SIGIR noted that the potable water

lines were embedded in the masonry walls and were constructed using polypropylene (plastic) pipe (Site Photo 6).

Site Photo 6. “Pilsatherm” water pipes embedded along exterior wall

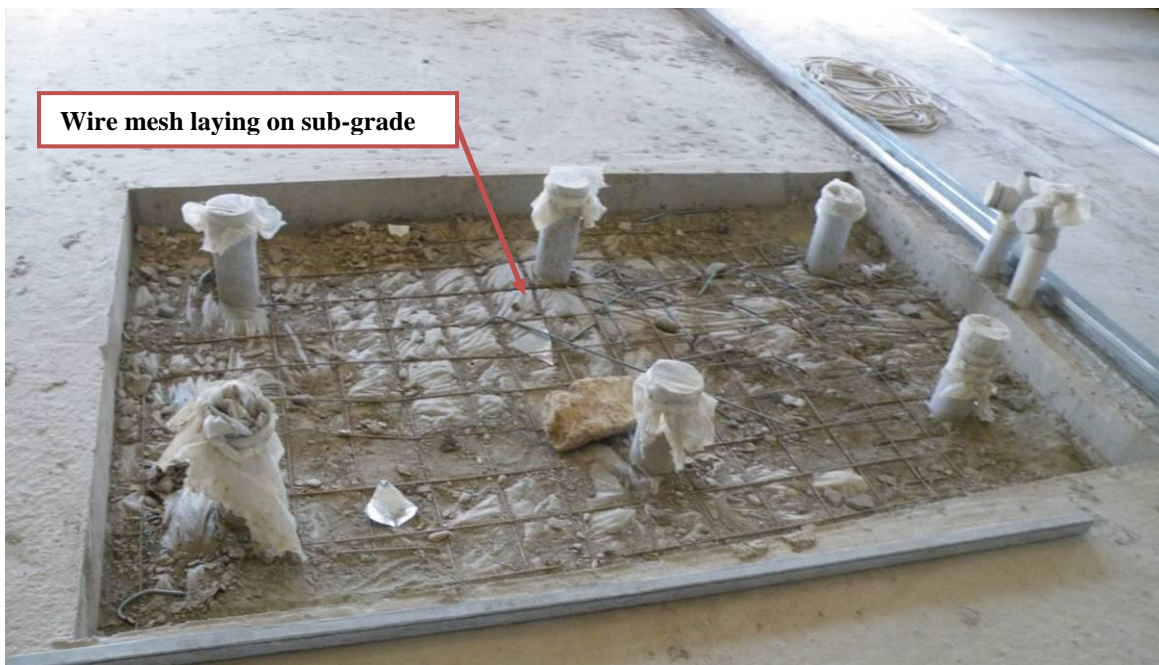
The SOW, Section 22.7.1 and 22.8.1 stated that the contractor was to provide sewer piping of “ductile steel with a minimum 100 millimeter (mm) diameter.” In the product data submittal documents provided by GRN, the COR approved the use of the Turkish pilsa (type of plastic) 9001 series pipe. Although SIGIR would not recommend the use of ductile steel pipe, the COR did not provide a contract price adjustment when approving the pilsa 9001 series pipe for the contractor to use. Also, the pilsa pipe data submittal provided by GRN was unclear as to whether the pilsa 9001 series pipe met the International Plumbing Code. At the time of the site assessment, the contractor installed the sanitary sewer piping under the concrete floor slab with polyvinyl chloride (plastic) pipe (Site Photo 7).

Wire mesh laying on sub-grade

Site Photo 7. “Pilsa 9001” sewer pipes under floor slab

Additional areas of concern that SIGIR and the GRN Mosul Area Office representative noted include potential changes to the generator requirements, concrete requirements, and storm sewer requirements. GRN should review these areas of concern and compare actual field construction versus the requirements of the SOW. In addition, GRN should determine if any cost savings are due to the U.S. government for the approval of alternative materials and methods.

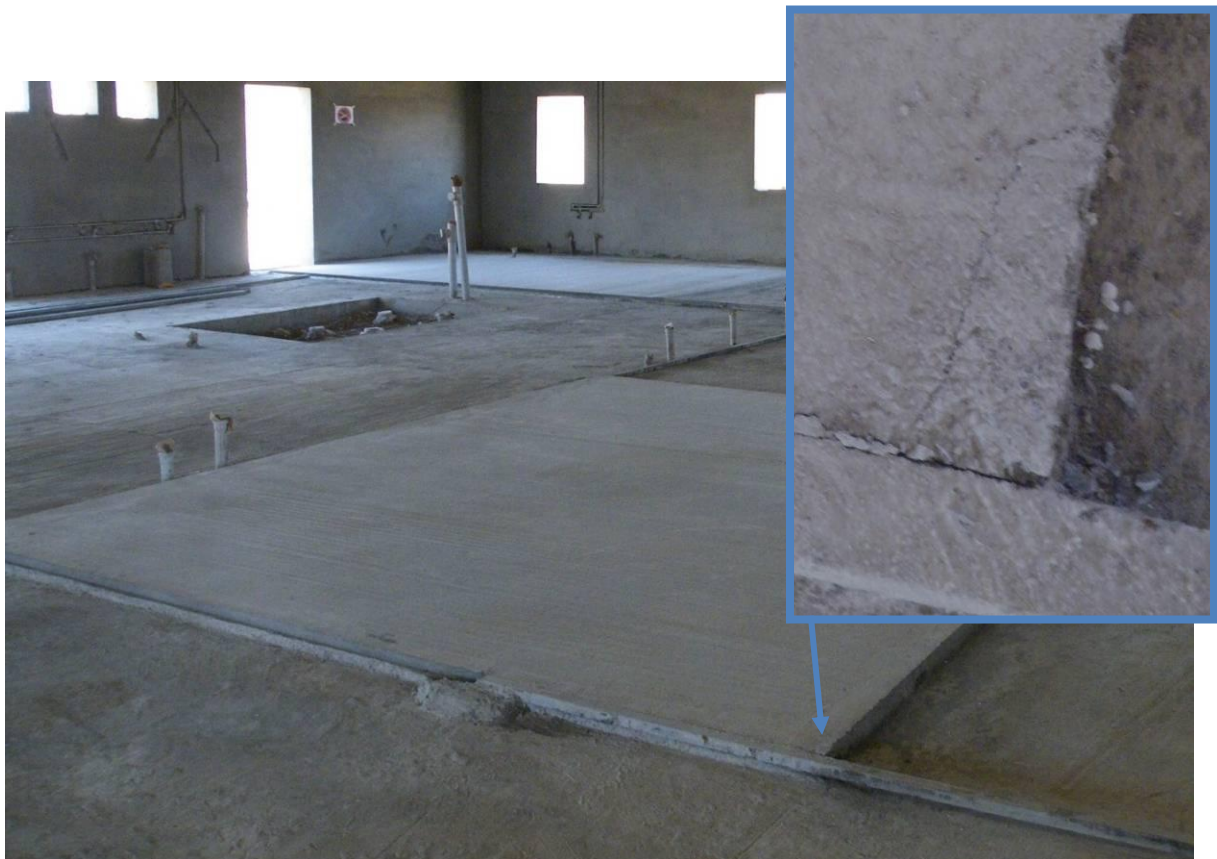
The concrete floor slab was constructed in two separate lifts (Site Photo 8). A thicker rough finish slab, estimated at 150mm thick, was poured throughout the building, except for areas where pipe penetrations were necessary. At the time of the site assessment, the contractor was starting to pour the second thinner mortar overlay, estimated to be 45mm thick, where the contractor was to lay the ceramic tile on top. SIGIR noticed that the construction of the floor slab showed improper jointing, unlevel construction, and cracking of the thin mortar overlay. In addition, SIGIR noticed from the missing sections of the floor slab that the wire mesh was laying on the sub-grade and was not lifted up properly (Site Photo 7).

Site Photo 8. Construction of mortar overlay on floor slab.

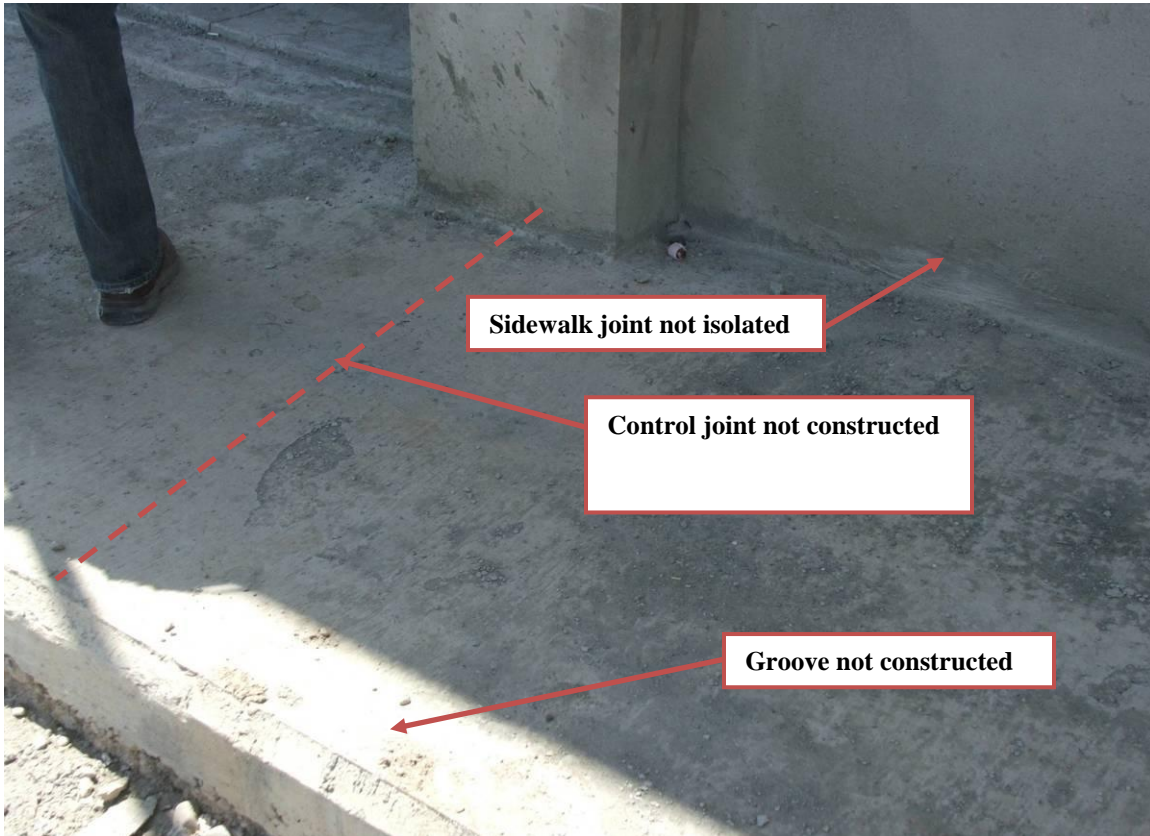
At the time of the site assessment, the exterior sidewalk was partially constructed; the construction was determined to be lacking an isolation joint next to the building, control joints, and a 200mm groove (Site Photo 9). Both the isolation joint and the groove were included in the 100% drawings submitted for approval (Figure 5). The control joints (contraction joints) were required every 1.2 meters (m) per a special note on the plans.

Site Photo 9. Construction of exterior sidewalk

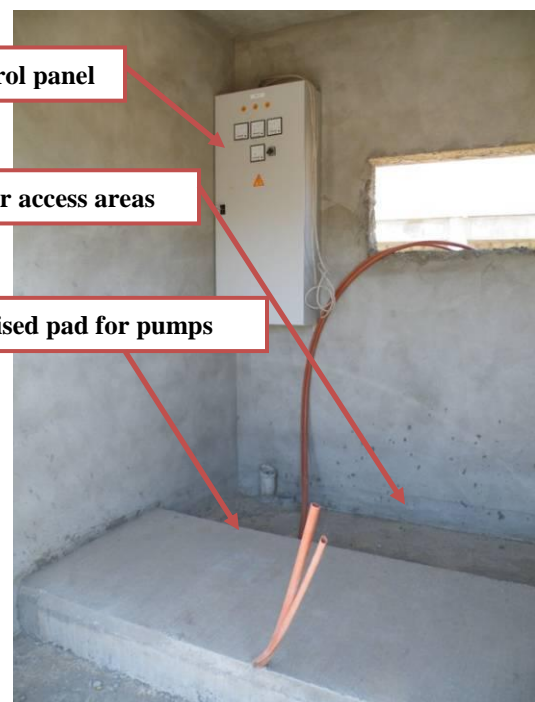
Although the construction of the water pump house was partially completed, SIGIR noted that the construction of the raised concrete pump pad was not constructed in accordance with the drawings (Figure 6 and Site Photo 10). Specifically, the raised floor as submitted on the plans was a 1.8m square raised concrete pad. The actual construction of the raised concrete pad was not configured in a square and did not allow for access against one exterior wall. Once the booster pumps are placed on the concrete pad, the access to the electrical control panel could be impeded. The original design allowed for unimpeded access all around the raised pump pad.

**Site Photo 10. 100% Water pump room
- actual construction**

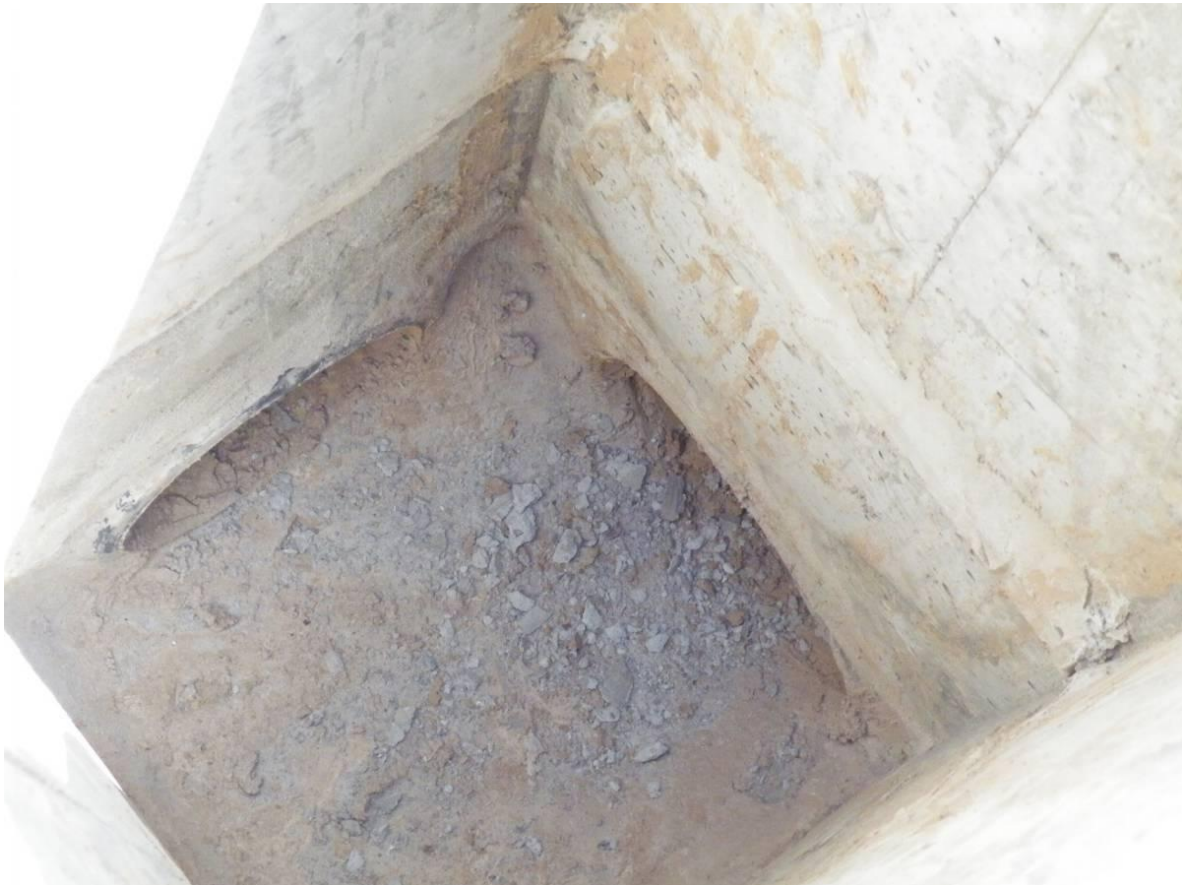
The sanitary sewer manhole contained debris in the bottom of the manhole and the sewer line. Also, the manhole lacked any access steps (Site Photo 11).

Site Photo 11. Sanitary sewer manhole with debris and no access steps

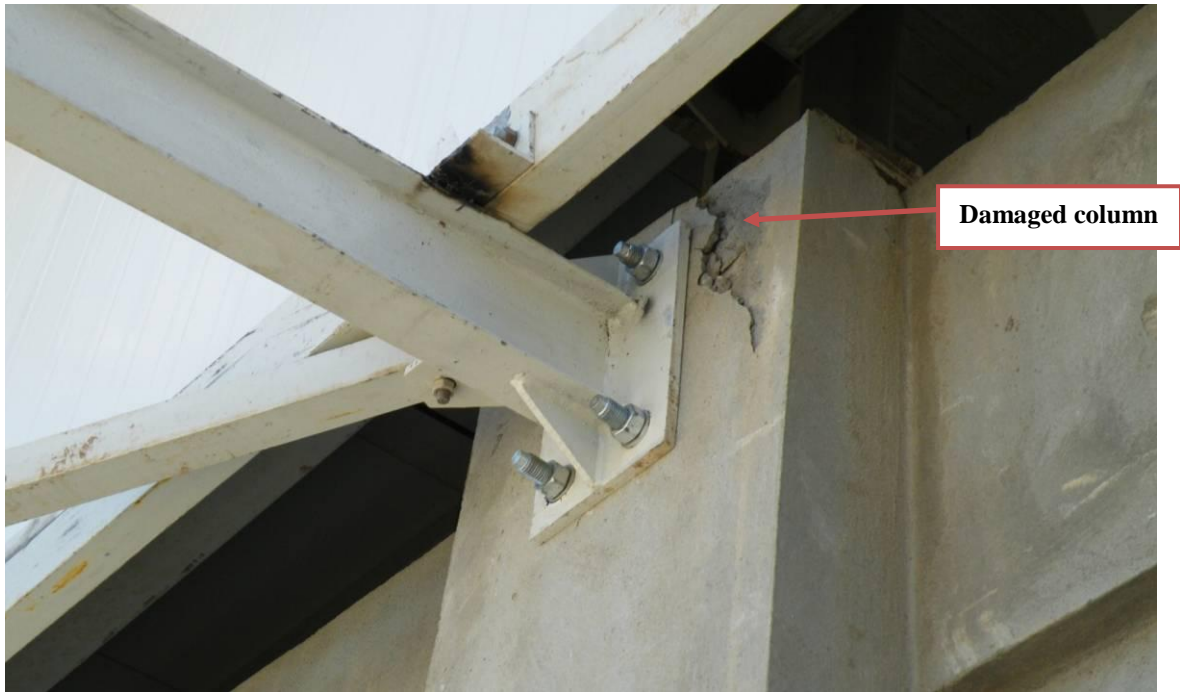
SIGIR determined that the construction of the perimeter awning was defective and required repair. The anchor bolts that attached the steel structural shade to the building columns were not embedded in the columns correctly and caused damage to the column (Site Photo 12). Also, SIGIR noted that the contractor hit steel reinforcement while drilling holes for the anchor bolts, which caused damage to the columns (Site Photo 13). If the anchor bolts were embedded in the columns before pouring the columns, the need for drilling holes would have been unnecessary. SIGIR found no evidence that epoxy or expanding fasteners were used to ensure that the anchor bolts were securely fixed into the columns. The anchor bolts should be load tested prior to the structural members being erected.

Site Photo 12. Column damage from unsecured anchor bolts

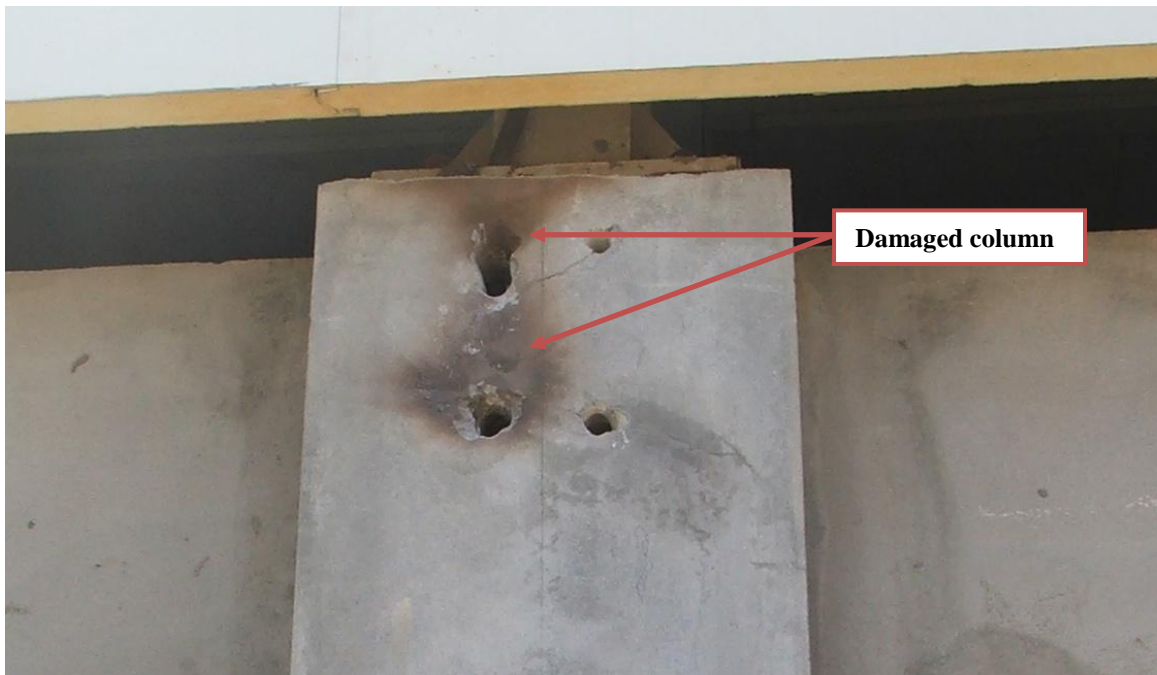
Site Photo 13. Column damage from drilling holes for anchor bolts

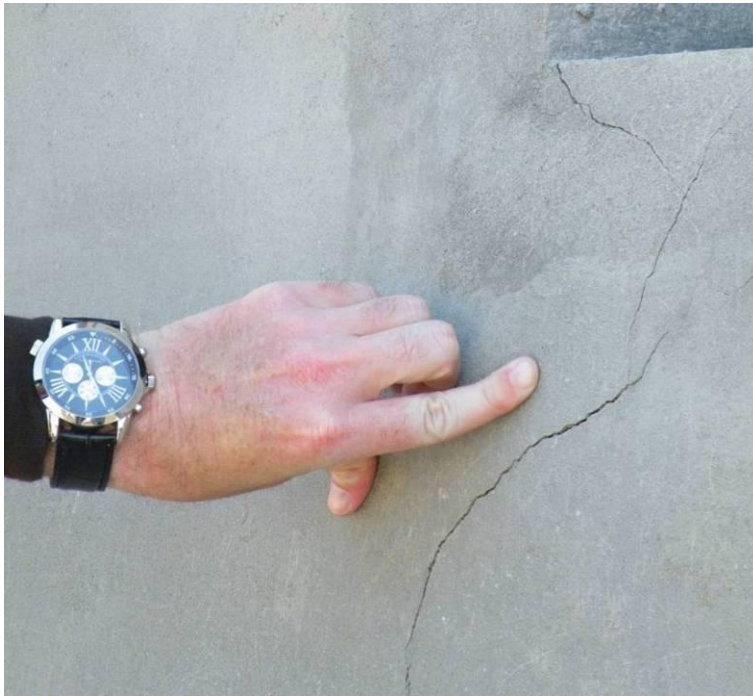
SIGIR observed that the west end of the building contained significant cracking of the mortar surface coating of masonry block and concrete columns (Site Photo 14). The damage appeared limited to the west end of the building. However, SIGIR was unable to determine why the damage occurred, and informed the GRN Mosul Area Office representative that the cracking could be due to shrinkage.

Site Photo 14. Cracking of the surface coating on the block walls and columns

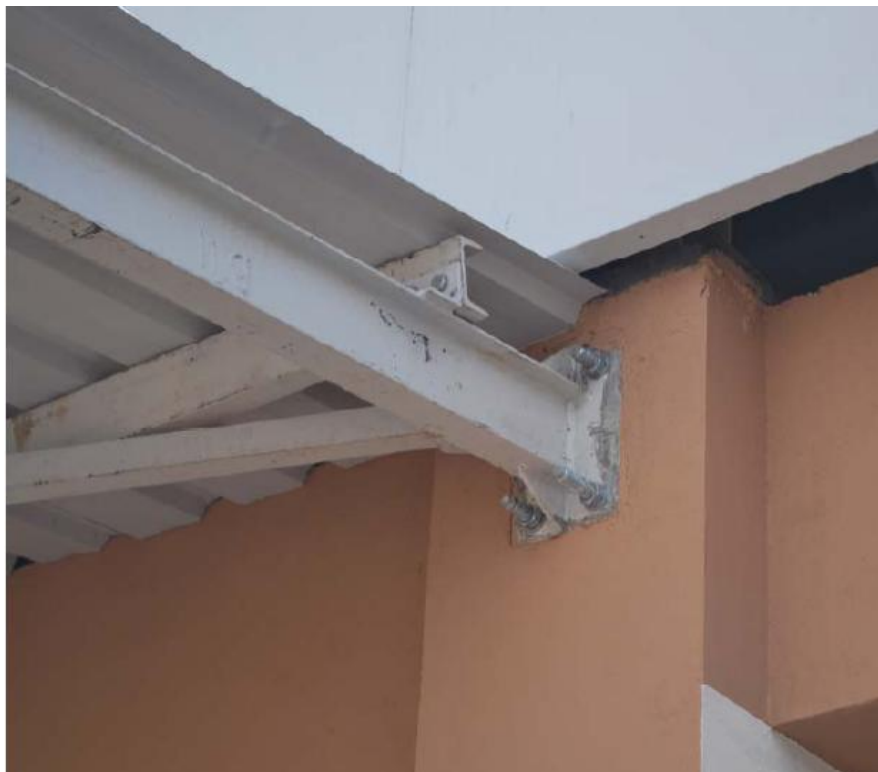
Site Photo 16. Corrective fix to the perimeter awning (Courtesy of USACE)

Subsequent to the SIGIR site visit, the Mosul Area Office representative provided information and photographic confirmation of action taken by the contractor on the perimeter awning issue. The photograph shows the repaired awning connection with the epoxy adhered anchor bolts embedded in the columns (Site Photo 16).
